Intel[®] Mobile Pentium[®] II Processor Specification Update

Release Date: December 2000

Order Number: 243887-027

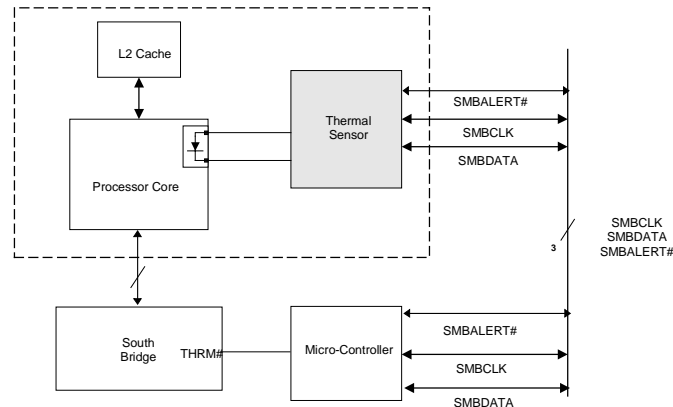
Figure 1. An Example of Microcontroller Driven Thermal Management

B30. Thermal Sensor May Assert SMBALERT# Incorrectly

Problem: The Mobile Pentium II processor and the Pentium II Processor Mobile Module have a thermal sensor that monitors the processor core's temperature. Please note that desktop systems could have a similar thermal device. The thermal sensor asserts SMBALERT# if the processor temperature exceeds the temperature limits set in the Alarm Threshold Registers (T_{HIGH} , T_{LOW}). It also sets the corresponding Status Register bits to identify the cause of the interrupt. Figure 1 gives one example of the how the SMBALERT# signal could be used in a system.

Under the conditions described below, the thermal sensor incorrectly generates the SMBALERT# interrupt. All of the following conditions must be met to trigger a false interrupt:
